The Locomotive

VOL. XXVIII. HARTFORD, CONN., JANUARY 25, 1910.

The Milwaukee Boiler Explosion.

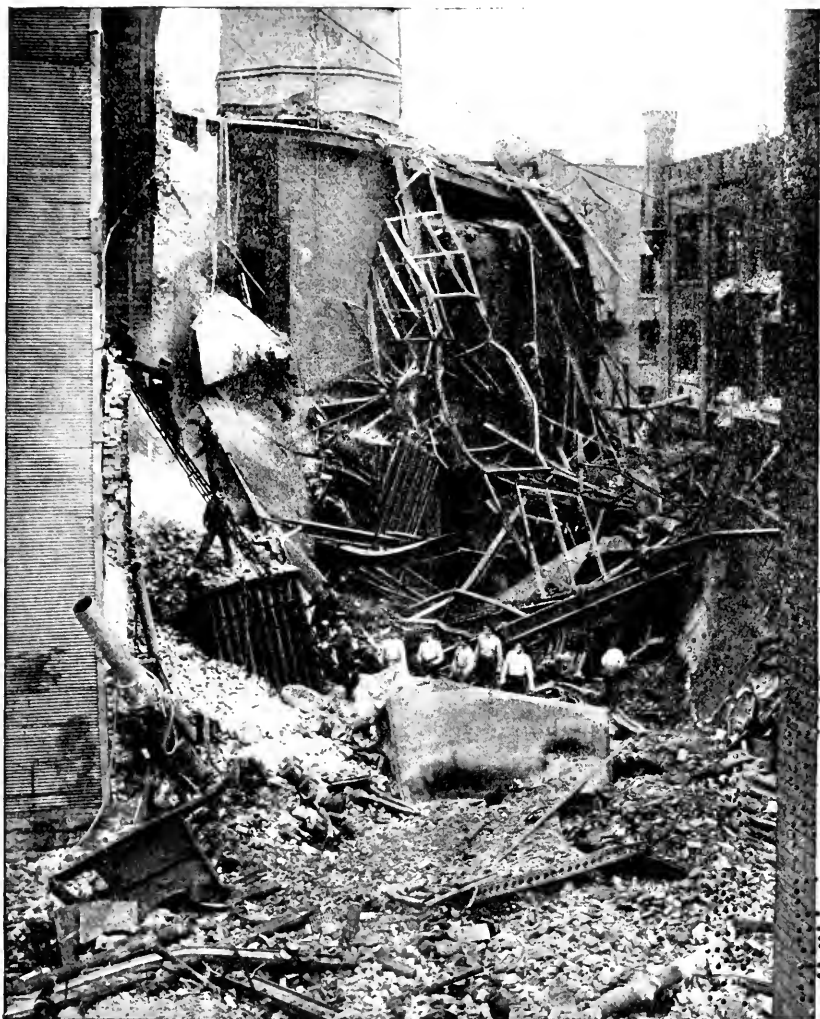
FIG. 1.—MILWAUKEE BOILER EXPLOSION: GENERAL VIEW OF THE WRECKAGE

A fearful boiler explosion occurred at 4:20 a. m., on October 25, 1909, at the plant of the Pabst Brewing Co., Milwaukee, Wis. Owing to the early hour at which the accident occurred, the only persons in the boiler room at the time were two firemen, Frederick Stirn and Gottlieb Jehmert. Mr. Stirn was killed, and Mr. Jehmert was seriously injured. The plant was badly damaged also, as will be evident from the illustrations presented herewith.

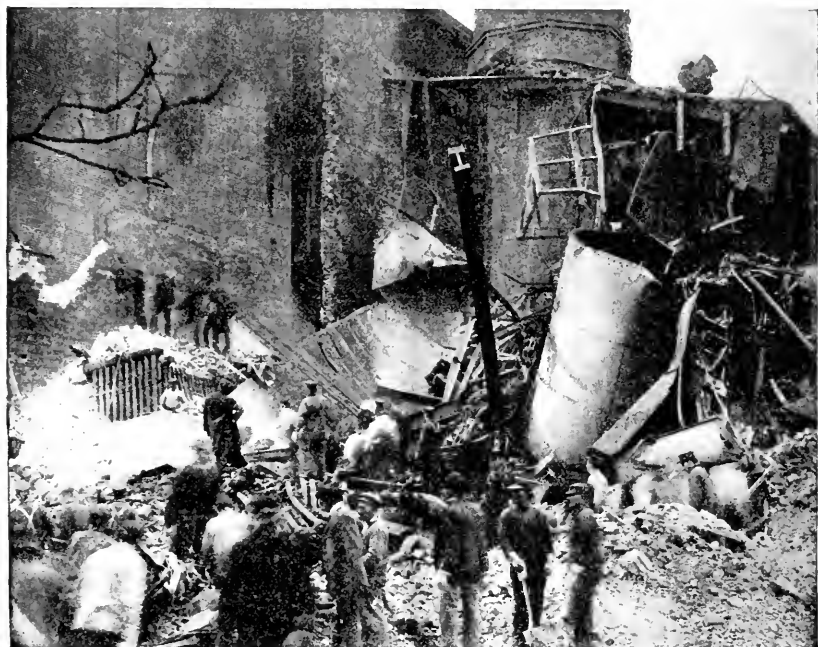
FIG. 4.—ANOTHER VIEW OF THE WRECKAGE.

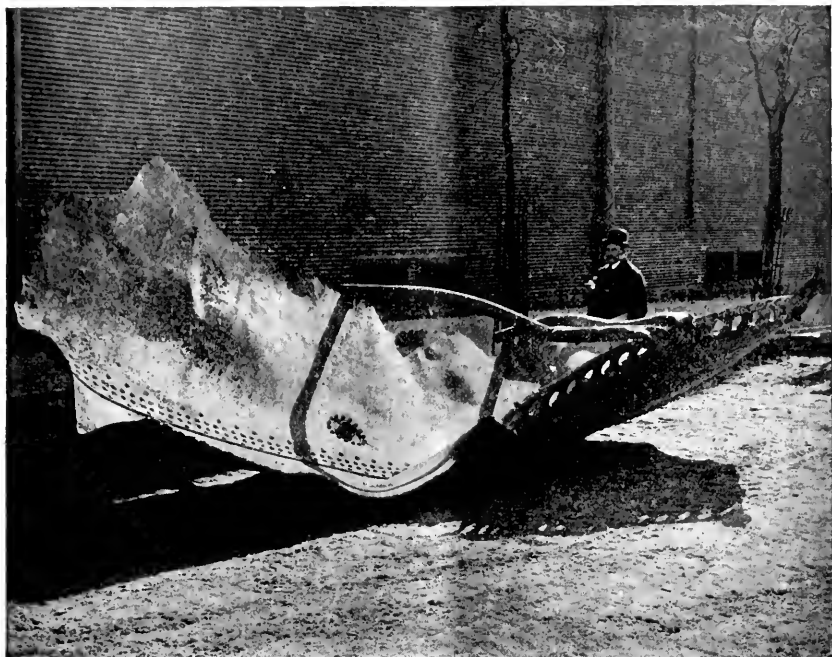
FIG. 5.—ONE OF THE RUPTURED DRUMS.

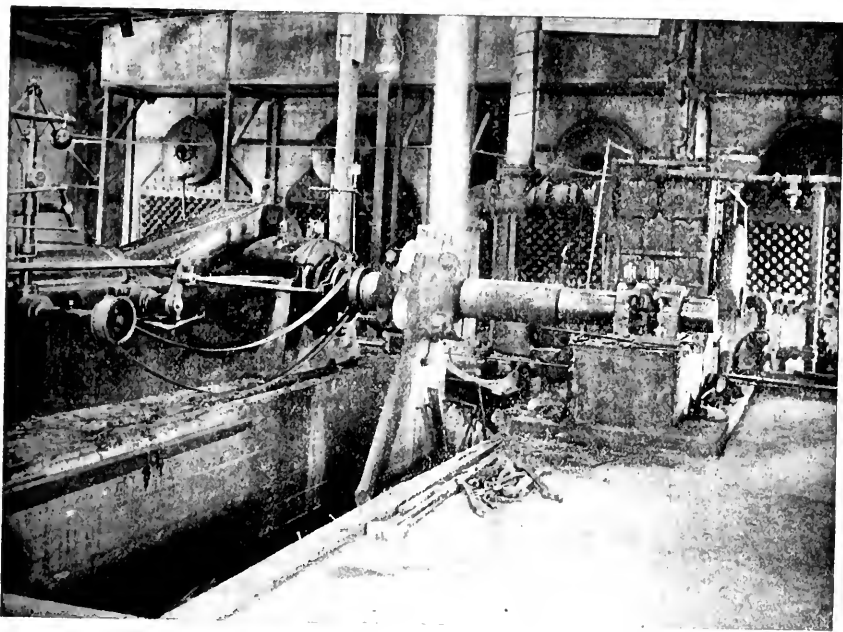
The accident described in the present article consisted in the explosion of a fly wheel, with disruption of the wheel, and the projection of its parts to considerable distances. It is well worth reporting and illustrating, for its own sake; and it also derives an added interest (at least for the Hartford Steam Boiler Inspection and Insurance Company and its policy-holders) from

FIG. 1.—VIEW OF THE WRECKED WHEEL. (LOOKING SOUTH.)

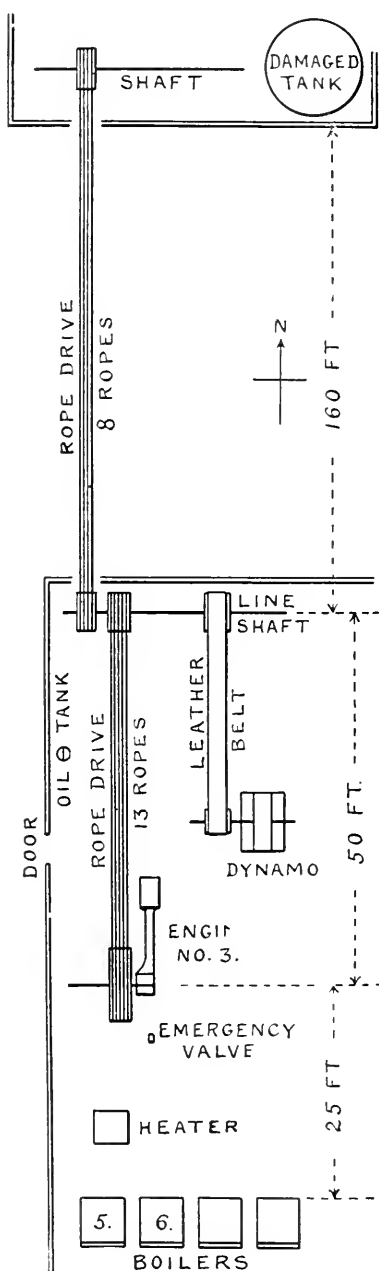
The wheel that burst was on an engine generating some 560 horse-power, and its normal speed was 100 revolutions a minute. It was a rope-drive pulley,

FIG. 2.—PLAN OF ENGINE ROOM.
(Not drawn to scale.)

14 feet in diameter with 13 grooves, and it drove a similar pulley, 7 feet in diameter, on a line shaft 50 feet distant, by means of a $1\frac{1}{2}$ inch continuous manila rope.

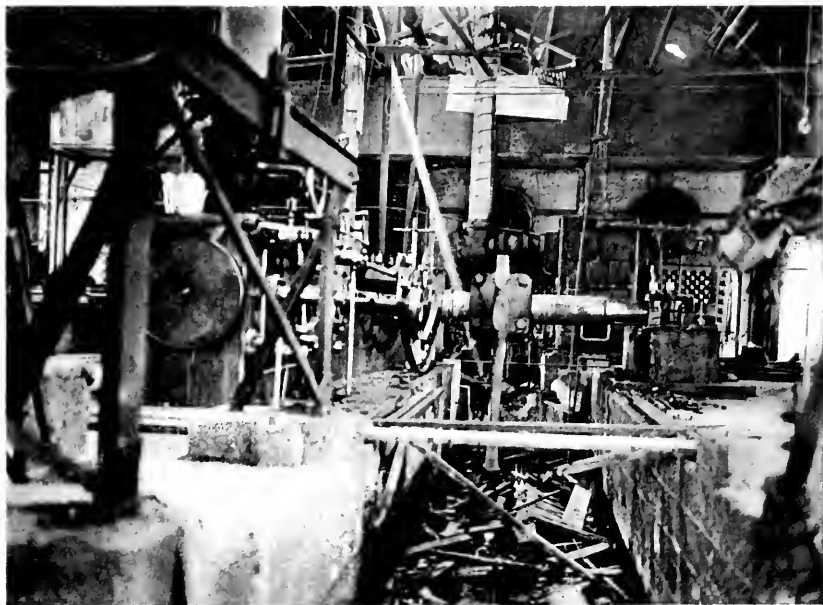
FIG. 3.—VIEW OF THE WRECKED WHEEL. (LOOKING SOUTH.)

Fragments of the ruptured rim were thrown about with great violence. One of the flanged joints was found to be intact, the section of rim in which it occurred being, after the rupture, $5\frac{1}{2}$ feet long as measured along the curved surface. This was the largest piece of the rim, and in the unbroken wheel it had extended from one spoke exactly to the next one, the flanged joint being in the middle of its length. The other flanged joint was broken, the line of fracture passing through the bolt hole in one of the flanges. A careful examination of this joint leads us to believe, however, that it did not fracture at the outset, but that it was broken after the failure of the wheel, by being thrown violently against one of the other wheels, or against a shaft. It was

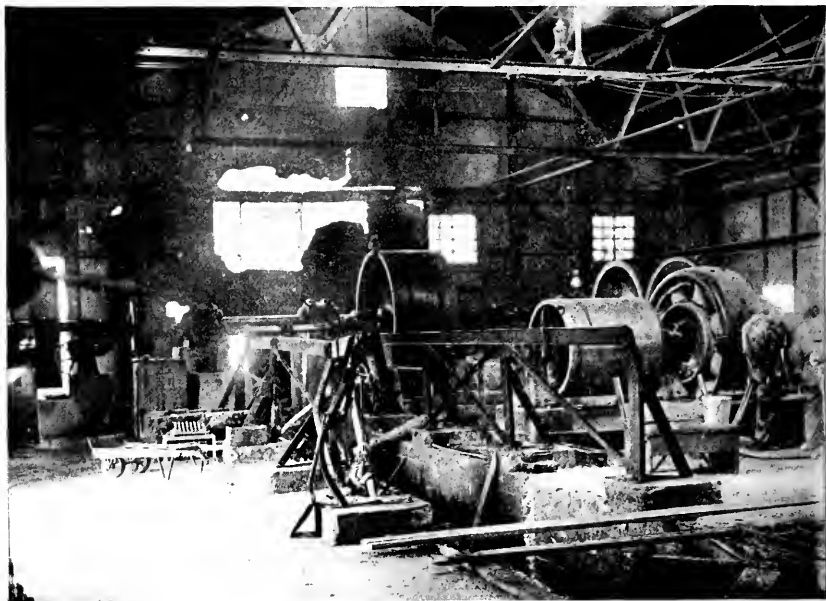
FIG. 4.—VIEW OF THE ENGINE ROOM. (LOOKING NORTH.)

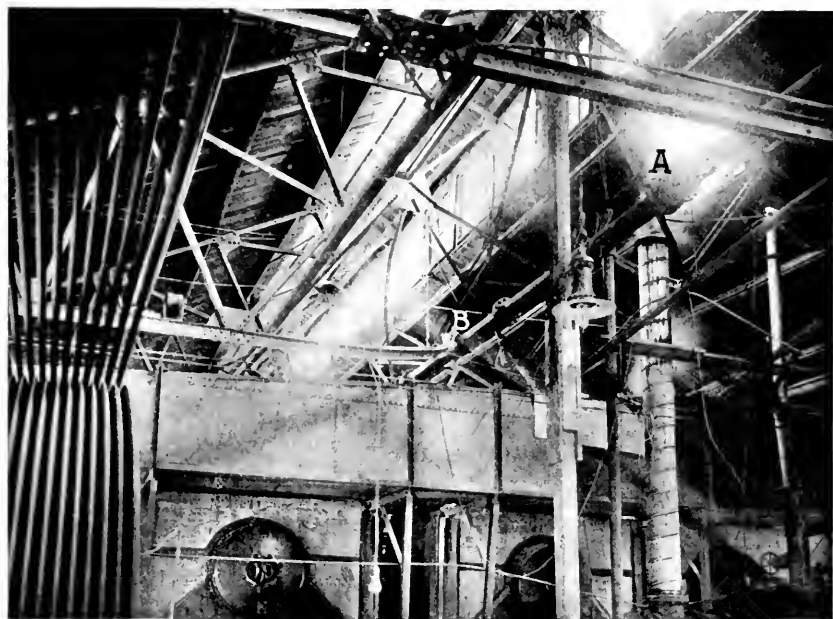
FIG. 5.—SHOWING THE EMERGENCY VALVE, A.

Eight days after the accident enough steam was given to the engine to turn it over, and, apart from a cracked main bearing cap and a slight spring in the crank shaft, the engine appeared to have suffered no great injury. After the crank shaft had been taken out, however, and properly centered on two pins fastened in two vertical 12 in. by 12 in. timbers, it was found to be sprung about $3/16$ in. The strain extended to the main bearing, as was to be expected, since the outboard bearing was shoved south, cracking the cement pedestal on which it rested, as may be seen in Fig. 1, on the right and directly under the end of the shaft. The crank disk was likewise found to be out by $3/32$ in., when the shaft was turned on the pins. The piston rod was then put in a lathe and was found to be sprung about $3/32$ in., and the connecting rod, when examined in the lathe in the same way, was found to be sprung about $1/16$ in. The total property loss was about \$4,200.

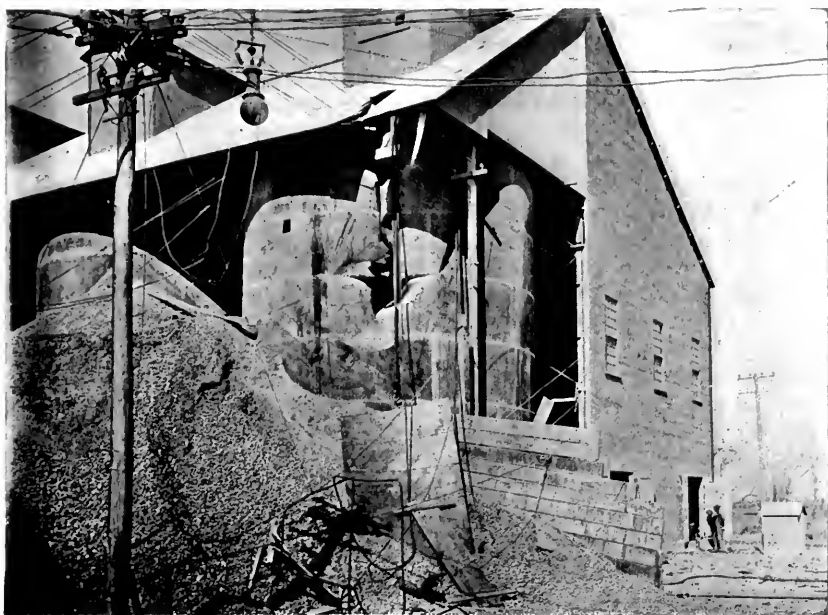
FIG. 6 shows the damage that was done to one of the large storage tanks. This tank was 16 feet in diameter and 25 feet high, and was built of $3/16$ in. tank steel. It was situated more than 200 feet from the fly wheel, as will be understood from Fig. 2. Fragments of the fly wheel rim struck this tank and tore it badly, so that it was necessary to replace 380 square feet of it with new sheets.

FIG. 6.—SHOWING THE DAMAGED STORAGE TANK.

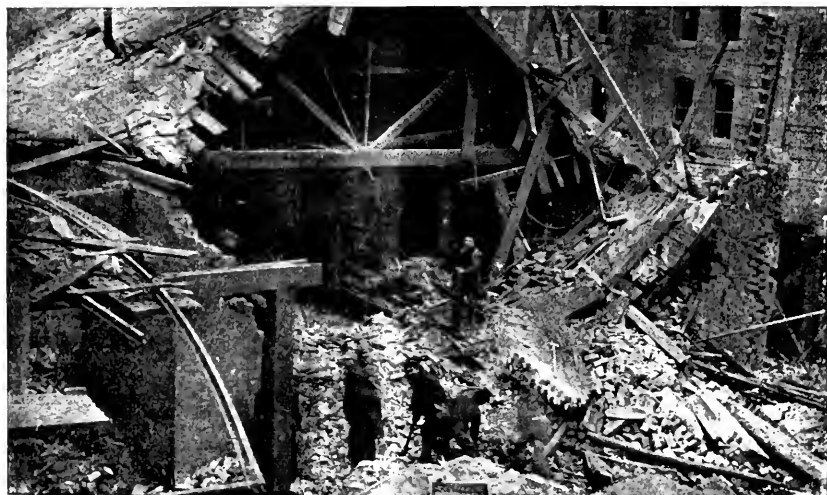
The factory in which the explosion occurred was a four-story brick building. All the floors gave way, allowing the entire machinery to fall to the

FIG. 1.—GENERAL VIEW OF RUINS.

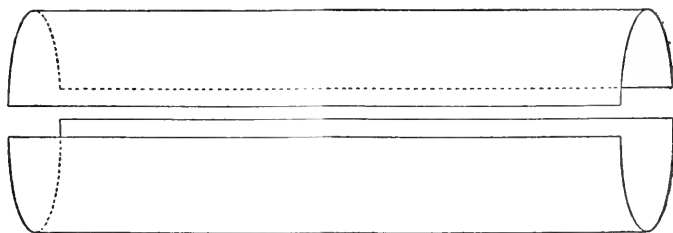
It will be noted that the manhole opening in the shell was so placed that its length extended in the direction of the length of the boiler. This design was formerly more or less common, and is still met with occasionally, though it is not to be commended. When a boiler is under pressure, the stress in the plate is twice as great in the girthwise direction as it is in the direction of the length of the boiler. Therefore the manhole opening should be cut so that its *least* diameter comes in the longitudinal direction. In the exploded boiler there was a ligament of plate only fourteen inches long between the edge of the manhole opening and the edge of the steam pipe opening, and it was apparently along this ligament that the initial rupture occurred.

FIG. 4.—ILLUSTRATING THE CONSTRUCTION OF THE SHELL.

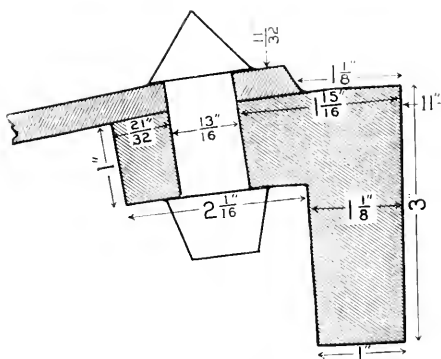
FIG. 5.—SECTION OF MANHOLE FRAME.

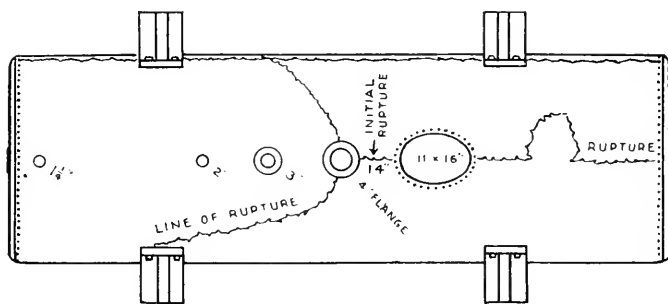
FIG. 6.—TOP VIEW OF BOILER, SHOWING INITIAL RUPTURE.

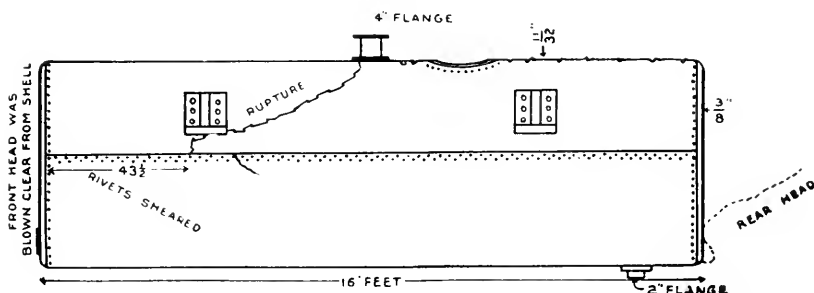
FIG. 7.—RIGHT-HAND SIDE OF BOILER, SHOWING LINES OF RUPTURE.

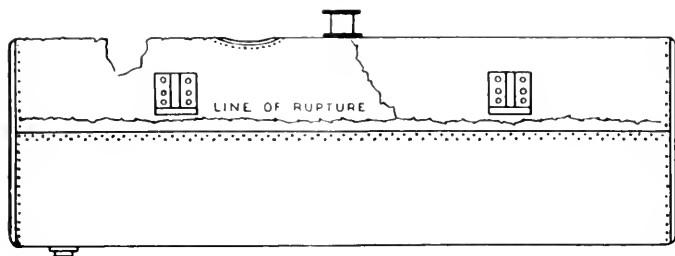
Taking all the ascertained facts together, we are of the opinion that the explosion was due either to a weakness developed at or near the manhole, or

FIG. 8.—LEFT-HAND SIDE OF BOILER, SHOWING LINES OF RUPTURE.

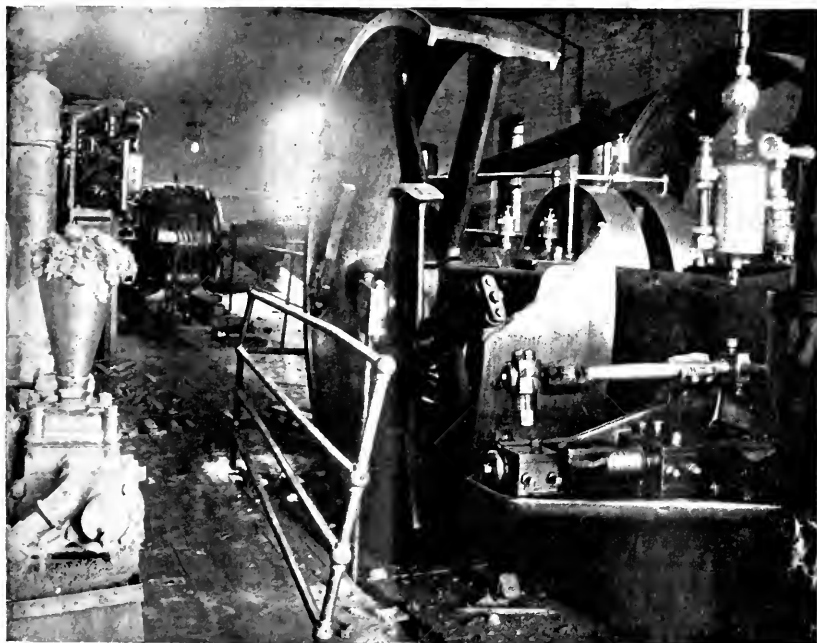
The bursting of a wheel on an "automatic" engine in the plant of the Towanda Electric Illuminating Co., at Towanda, Pa., in the early morning of April 20, 1911, gives striking evidence of the incorrectness of the popular opinion that engines of this class are immune from such explosions. A brief description of the attendant conditions, and a discussion of the probable cause of failure, should therefore be of interest.

FIG. 1.—SHOWING THE BROKEN WHEEL AND GOVERNOR.

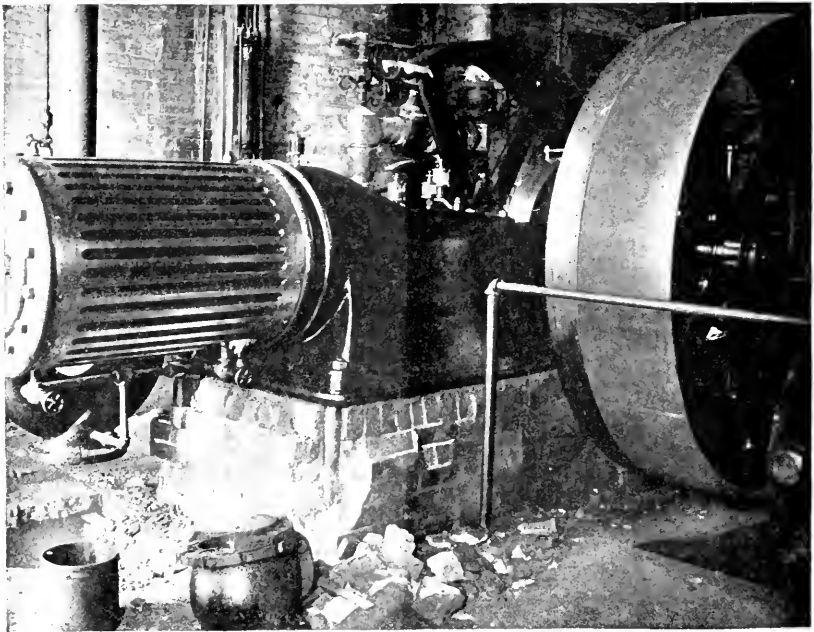
FIG. 5.—SHOWING THE DAMAGED FOUNDATION.

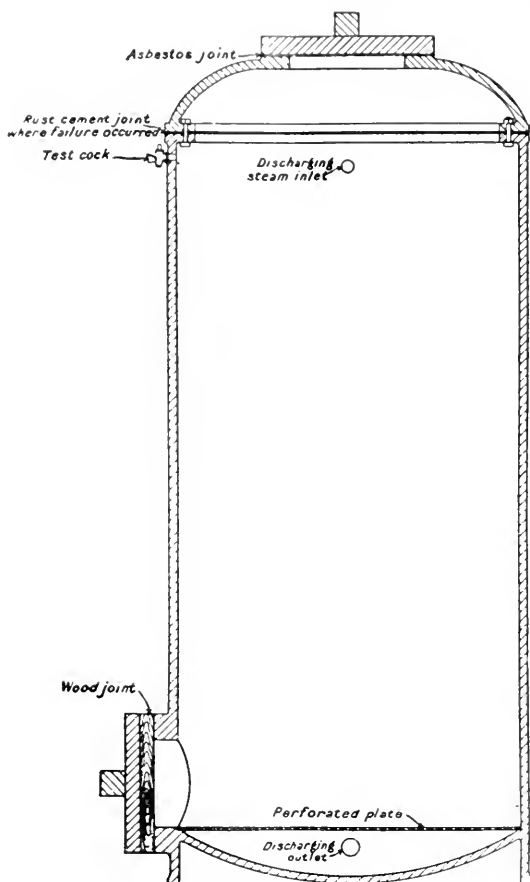
The apparatus, which was used for extracting dye from dye-wood, consisted of a vertical cylindrical cast-iron vessel 3 feet in diameter, and 7 feet 2 inches in height. The cover or top of the vessel was dome-shaped, and was secured to the body by means of internal flanges fastened together with 24 bolts originally 9/16 inch in diameter. The flanges had not been machined or faced in any way, but they were made steam tight with a rust joint the thickness of which varied from 1/8 inch at the inner edge to 5/16 inch at the outer edge.

There was a hole 12 inches in diameter in the center of the cover, which was fitted with a suitable door, and was provided for the purpose of charging the apparatus with dye-wood. An elliptical hole, 13 1/4 inches by 9 1/4 inches, with a suitable door, was provided in the side of the vessel near the bottom for withdrawing the spent charge, and which could also be used as a man-hole for internal examination. A perforated plate, having holes 1/8 inch in diameter, pitched 1 inch apart, was fitted near the bottom of the vessel to act as a strainer when the liquor was being discharged.

A branched wrought iron pipe, 1 1/4 inches in diameter, was fitted near the top of the vessel for the admission of hot water when preparing the charge, and steam when discharging the liquor. The branch leading to the water supply was provided with a cock, and a valve was fitted on the steam branch. The heating steam pipe, which was 1 1/4 inches in diameter, entered the vessel at the bottom, and was provided with a cock. A 2-inch pipe and cock was also fitted to the lower part of the vessel for discharging the liquor into a receiving tank overhead, the open end of the pipe being at a height of 15 feet above the bottom of the apparatus. There was a 1/2-inch test cock fitted on the front of the vessel near the top.

The apparatus was not provided with either a safety-valve or pressure gage.

The cause of the explosion was that the pressure of steam in the dye extractor was more than it could withstand. Its strength when new was not equal to a pressure of more than 19 pounds per square inch, but when it exploded the bolts which held the cover were much corroded. Half were eaten through and the rest reduced from 9.16 of an inch to $\frac{3}{8}$ of an inch in thickness, while the greater part of these were fractured.

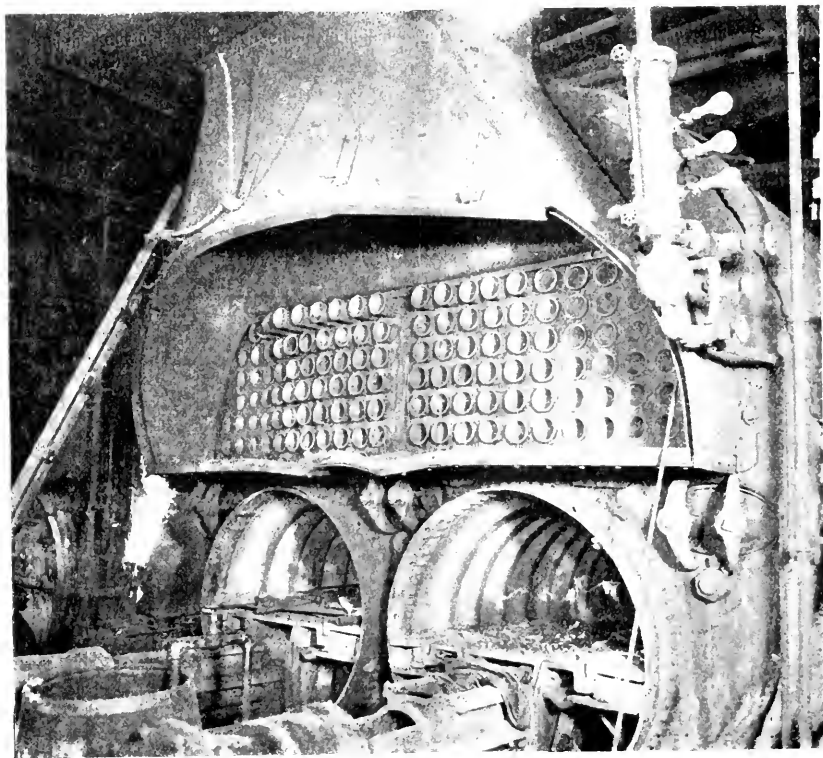
The vessel was what is known as a "wet back boiler." The general construction of such a vessel is shown by the line cut, Figure 2. The tubes and flues terminate in an internal tube sheet, "D," and communicate with a combustion chamber, "A," within the shell. The back of this chamber is formed by a sheet, "B," stayed to the rear head, "C." The space between sheet "B" and head "C" is filled with boiler water under pressure and gives the name "wet back" to the type. It was the bursting of this "wet back" and the consequent collapse of the combustion chamber that occasioned the disaster. Its initial cause was the pulling off of sheet "B" from the 172 staybolts which held it.

FIG. 1. DAMAGED FRONT OF BOILER.

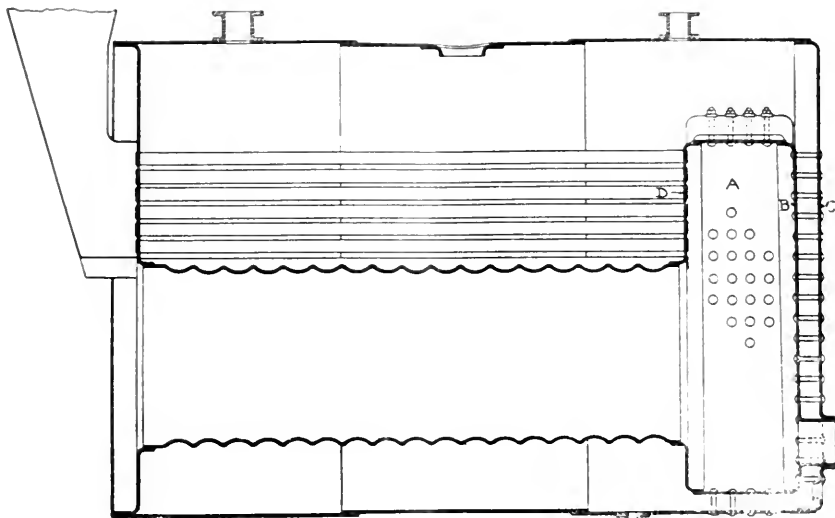
An investigation disclosed the fact that the holding power of many of these staybolts had been greatly diminished by the buckling of sheet "B" between them, this buckling causing the staybolt holes to take a conical shape with the larger diameter of the cone on the outer side of the sheet. This deformation of the holes disengaged the threads to such an extent that those remaining were unable to support the load imposed on them by the boiler pressure.

The boiler at the time of the accident was connected in line with seven others, on which all pop valves were set to 105 lbs. per square inch, so there is a reasonable certainty that the pressure did not exceed this amount. The staybolts on sheet "B" were $1\frac{1}{8}$ inches in diameter and spaced $7\frac{1}{4}$ inches apart each way, and the sheet was $15\frac{32}$ of an inch in thickness. The only

FIG. 2. SECTION OF BOILER.

plausible explanation as to how a pressure which did not exceed 105 lbs. could seriously buckle a sheet of this thickness held by stays in the manner described, is that the sheet was weakened by overheating.

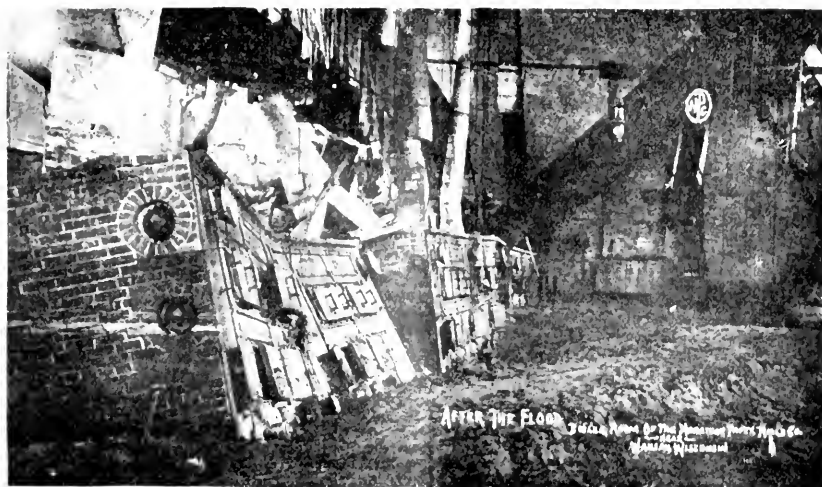
The accompanying illustration shows the condition in which the boiler plant of the Marathon Paper Company was left by a flood of the Wisconsin River, on which at Wausau, Wisconsin, that company's mill is located. Unusually heavy rains in the early part of last October had caused high water in all the streams of that neighborhood, and on the sixth of the month the Wisconsin had burst its banks and overflowed the Marathon Company's property, cutting new channels between its buildings, and as it developed, undermining the boiler foundations. Late in the afternoon of that day, before the water had reached the boiler room floor and while steam was still maintained, an initial settlement occurred in the end one of a battery of six boilers. This caused a break in a feed pipe by which three of the attendants were seriously scalded. Soon after, the water invaded the room and operations had to be suspended. At 8:30 in the evening the foundation completely collapsed at the rear, wrecking the

WRECKED BY A FLOOD.

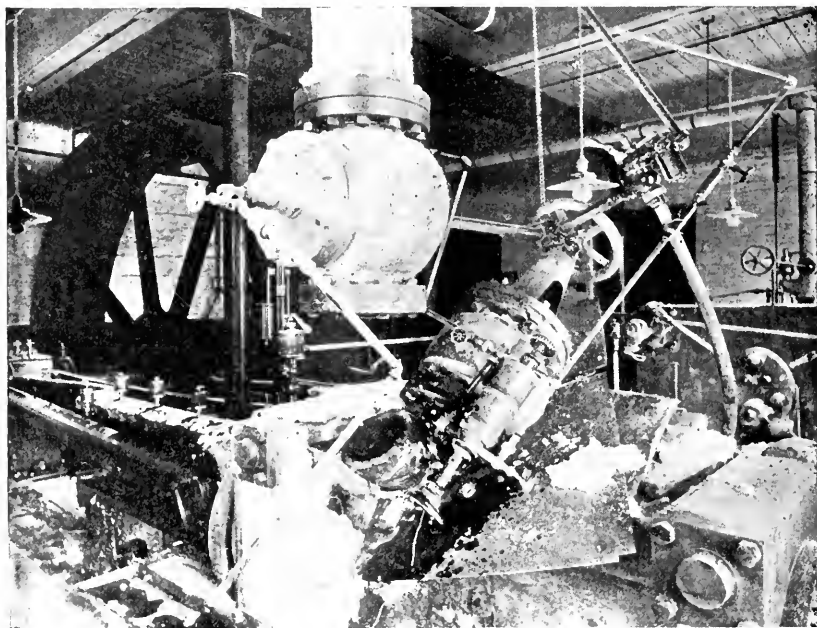
The facts as stated by those in charge of the engine at the time of the accident were corroborated by the conditions found upon this examination. The engine was a cross-compound Corliss built by the Wm. Harris Steam

FIG. 1. A PECULIAR ENGINE ACCIDENT.

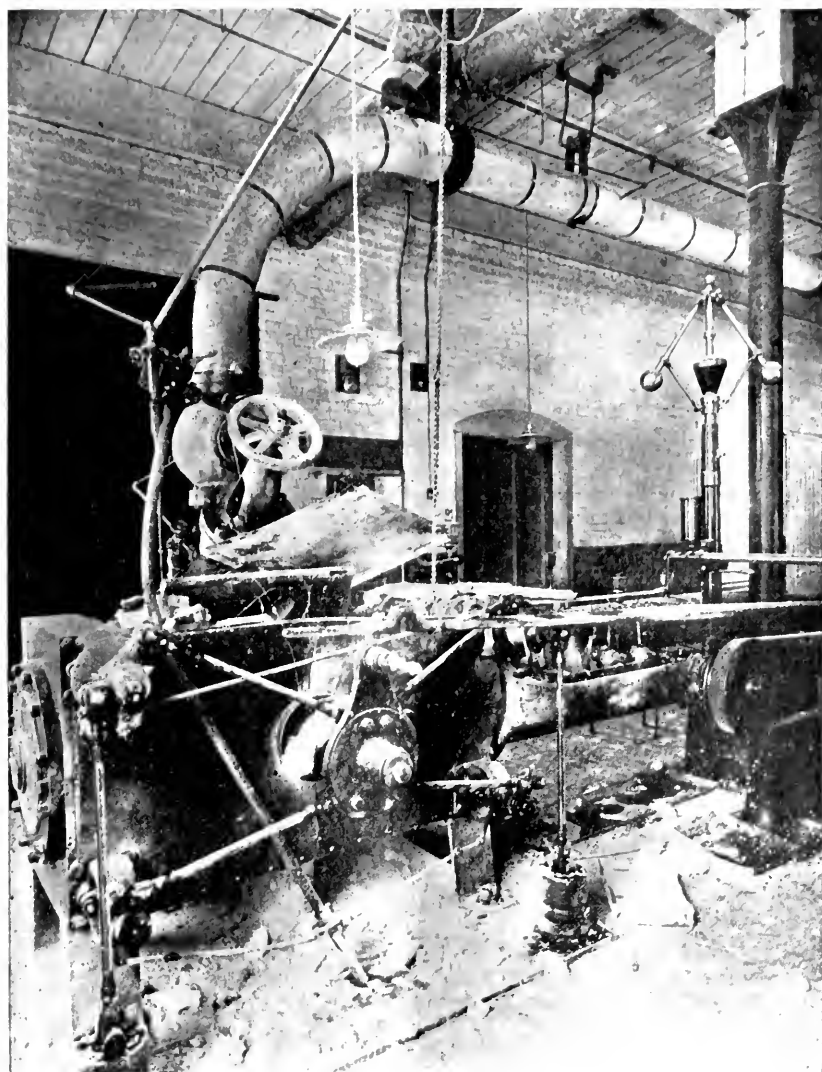
The results of the accident, which occurred while shutting down the engine at 6 P. M., are clearly illustrated in Figures 1 and 2. Owing to the necessity

FIG. 2. A PECULIAR ENGINE ACCIDENT.

judged that one or two more revolutions of the fly wheel would be the last, when an explosion occurred with the results as shown.

Another objection to such a theory is that both the steam inlet valves and the throttle valve were closed and on this account there seems no good reason why water coming through the steam pipe should be moving with any considerable speed. The top of the steam chest was rather weakly constructed, being about 1 inch thick and 47 inches long by $14\frac{1}{4}$ inches wide and not stiffened in any manner by ribs.

The Master Mechanic of the mill thought that the elbow was broken in some manner by expansion of the pipe line, and that the main steam pipe was thrown up by the outrush of steam and fell back on the elbow, when the automatic valve closed, delivering a blow that broke in the top of the steam chest. This theory is very plausible as it would explain the position the parts were found in, but no marks could be found on the broken end of the elbow, or the flange attached to the Locke automatic stop valve, to show that such a blow had been delivered. That the steam pipe was thrown up quite a distance at the time of the accident is indicated by the bent hangers and broken air duct shown in the upper part of Figure 2.

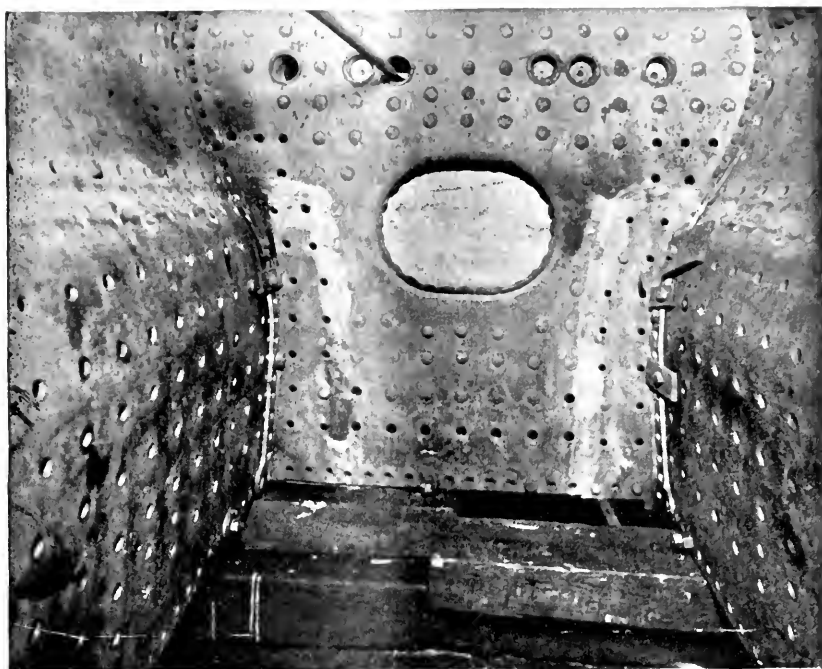
FIG. 2. WELDED FIRE-BOX.

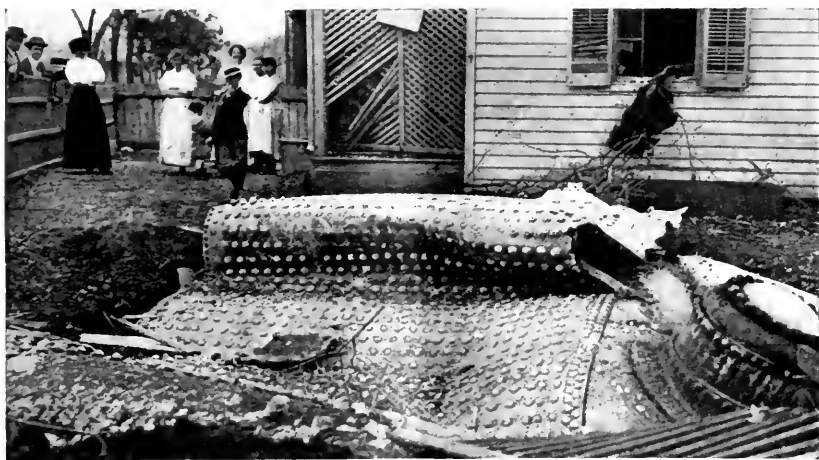
FIG. 2. WRAPPER SHEET AND DOME IN DOOR YARD.

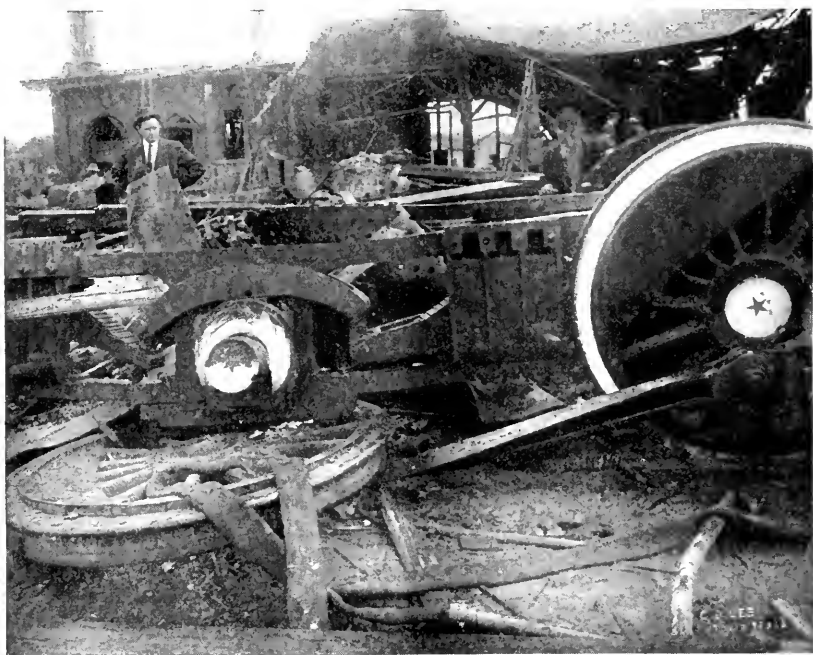
FIG. 3. DRIVER BLOWN FROM AXLE.

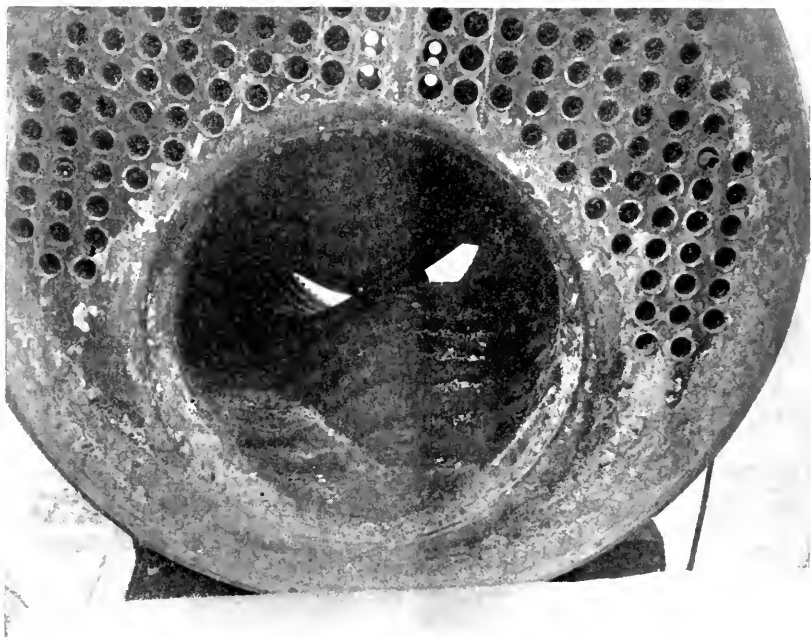
FIG. 2. THE COLLAPSED FURNACE.

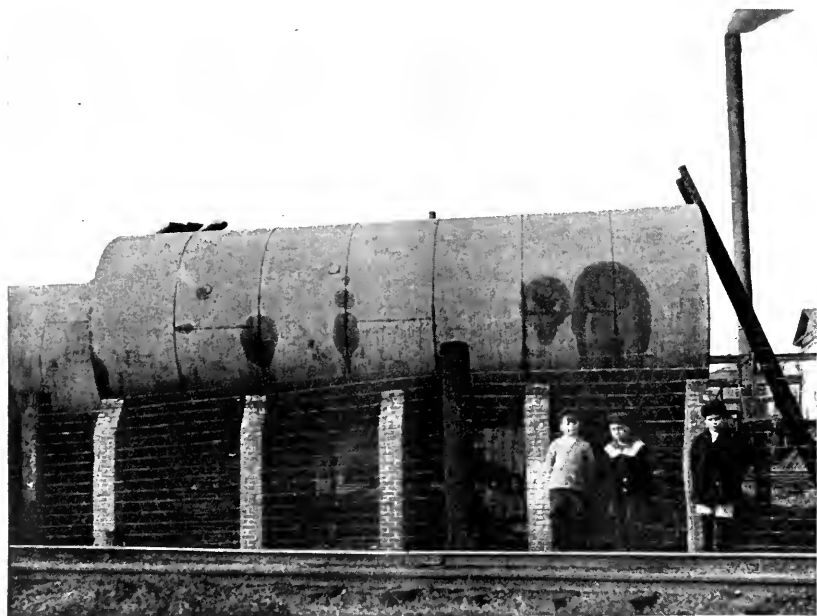
FIG. 2. THE PATCHED OIL TANK.

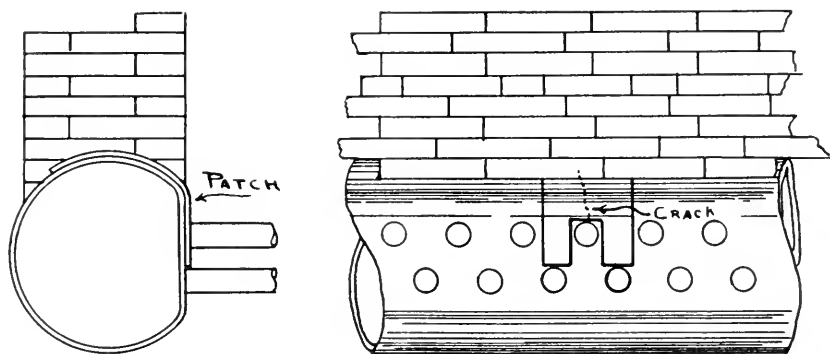
It is not known what pressure was attained after the repair was completed, as the attendant was kept so busy in a fruitless effort to maintain a fire in the furnace against the flow of water from the fracture, that he failed to note the reading of the pressure gage. Nevertheless the patch was not blown out of the furnace, and the greatest damage was to the purse of the mill owner.

FIG. 2. PATCH BRICKED AND CEMENTED IN PLACE.

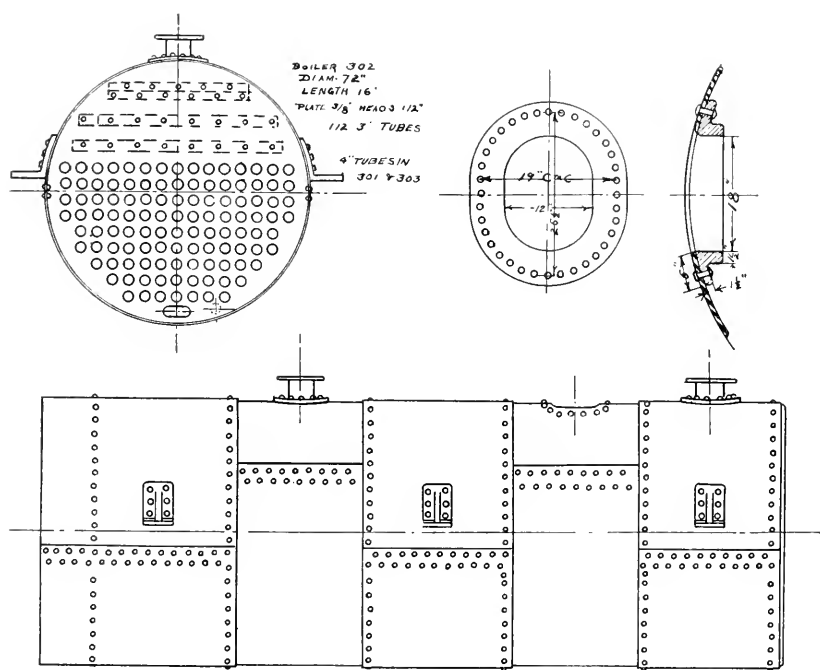
FIG. 1. DETAILS OF BOILERS 301, 302, AND 303.

The report of the HARTFORD's inspector shows that these boilers, aside from age were in apparent good order. There was evidence that no rivets had been replaced, and that the seams had never been chipped and caulked. No fire cracks were visible, and although there was a slight indication of overheating on the bottom sheets of the rear courses, this was considered trivial. The only repairs known to have been made, were several complete renewals of the tubes.

These boilers had been designed for a pressure of 100 lbs., but owing to the low factor of safety which they would have at this pressure, due to the low efficiency of the longitudinal joints, they had been worked at a pressure of 80 lbs. At this pressure, the actual factor of safety, based on the pressure of 260 lbs. at which the manhole frame of boiler No. 301 failed was only 3.25.

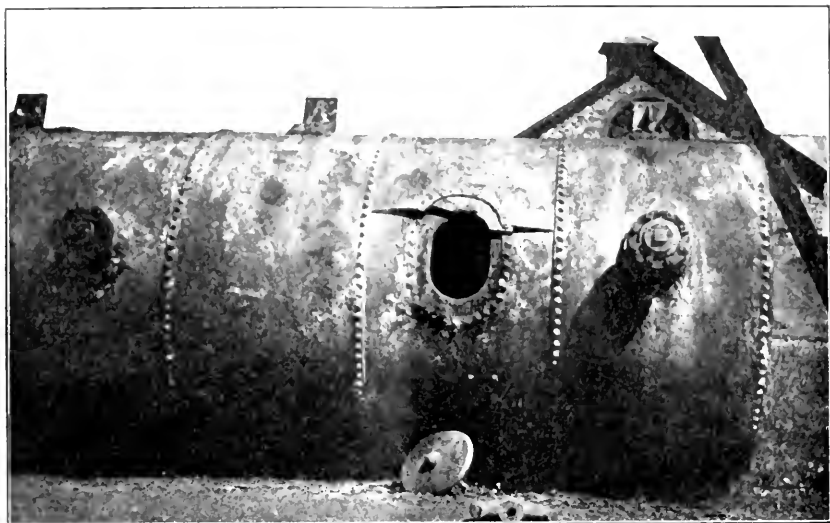
FIG. 2. SHOWING THE BROKEN MANHOLE FRAME OF BOILER 302.

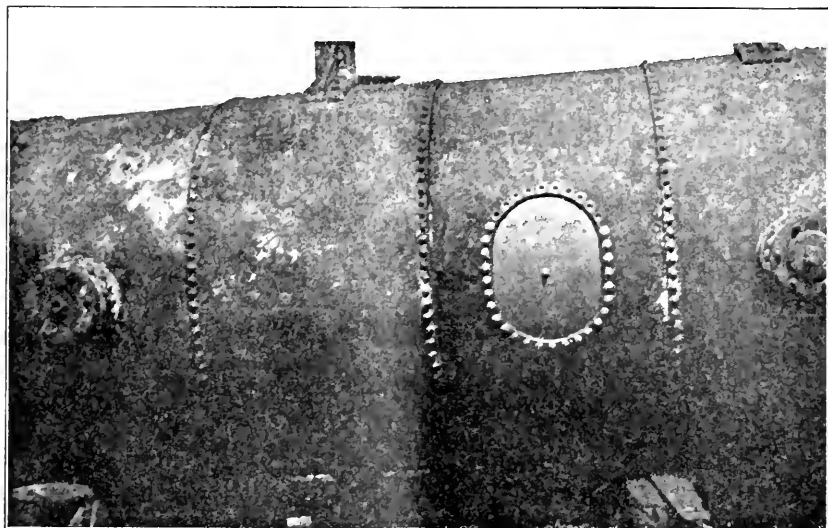
FIG. 3. APPEARANCE OF BOILER 303 AFTER TESTING.

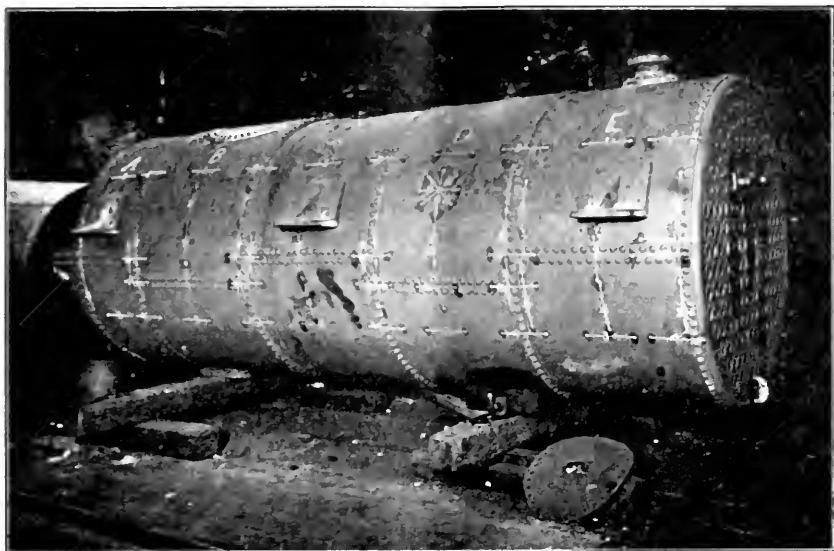
FIG. 4. BOILER 4092 PRIOR TO THE TEST. NOTE THE 10-INCH GAGED LENGTHS.

sheet. Their appearance prior to the test is shown by Fig. 4. The longitudinal joints were double riveted lap seams, $\frac{3}{4}$ inch rivets, pitched 2 inches, placed in punched holes. The plate thickness was $\frac{3}{8}$ inch for the shell, and $\frac{1}{2}$ inch in the heads. Both boilers contained 140 three inch tubes. Domes 2 feet 6 inches in diameter were provided on the second course, and cast iron man-hole frames and safety valve nozzles were fitted to the middle and rear courses, respectively. Both boilers were made at the shops of the Whittier Machine Co., Boston, Mass., in 1881, of "Benzon" steel. They were known as No. 4084 and No. 4092 on the HARTFORD's records, and were designated by these numbers in the report of the test published in the November 1911 number of the *Journal of the American Society of Mechanical Engineers*.

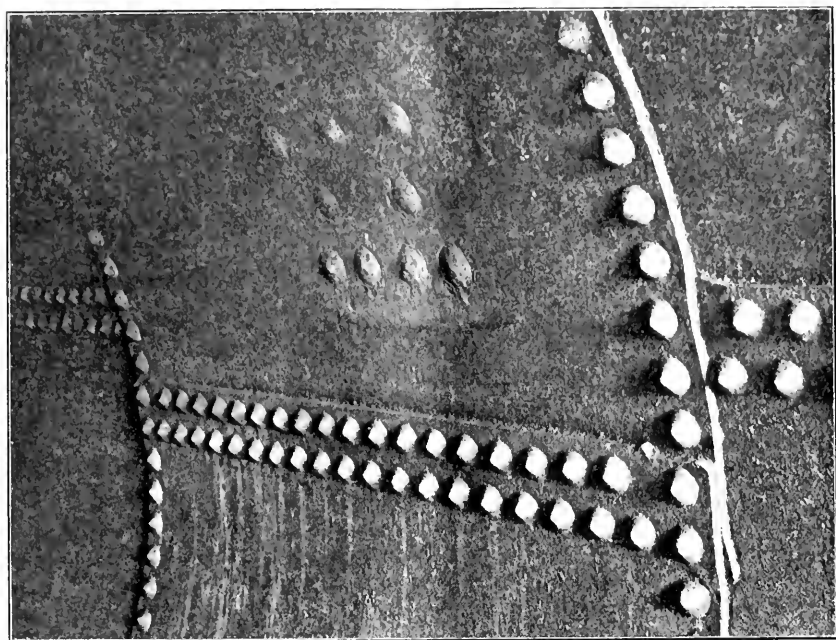
FIG. 5. SHOWING THE EVIDENCE OF DISTRESS UNDER THE LUGS AND AT THE LONGITUDINAL JOINT.

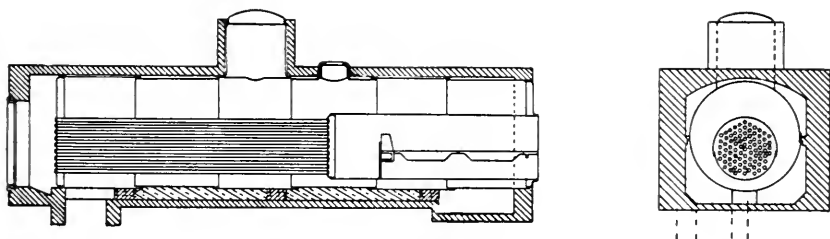
FIG. 6. BOILER KNOWN AS S-3.

Creusot, and were of the type illustrated in Fig. 6, cylindrical, with internal furnaces and direct tubes, surmounted by a dome. The settings were such that the products of combustion passed first through the tubes, then returned under the right-hand side of the shell to the front, where they passed across, and back to the flue, under the left-hand side of the shell. A longitudinal baffle wall for this purpose was provided under the center line of the boiler as is indicated in Fig. 6. The boilers were designed for a pressure of 71 lbs., but were later tested and worked at 78 lbs. (5.5 kg. per sq. cm.). They had a heating surface of 1270 sq. ft., were oil fired, and forced day and night except Sundays, for more than 30 years. In 1900 the rate of firing, which is typical of the service they rendered throughout their life, was such as to consume about 150 kg. of oil per sq. meter of grate per hour, which is equivalent to 31 lbs. of oil per sq. ft. of grate per hour, a very high rate indeed. The evaporation obtained was about 6 lbs. of water per lb. of fuel. The material of which the boilers were constructed was Creusot wrought iron, designated by the following numbers: body of the boiler, No. 2; heads, lower furnace sheets, and domes, No. 4; upper furnace sheets and front tube sheets, No. 6. The entire battery was overhauled between 1905 and 1907, as the result of a general breaking down from old age, and has since been entirely replaced. This overhauling however gave the opportunity for obtaining test specimens, and the data given was obtained at this time.

In January 1905, a crack developed in one of the boilers, known as S-3, in the bottom of the third course, in the fourth girth seam, necessitating the removal of a portion of the sheet. Eight specimens for tensile test of standard (eight inch) size, were cut from this sheet and broken with the following average results:

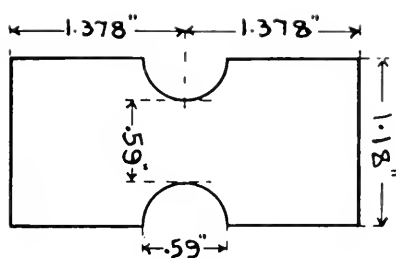
FIG. 7. IMPACT TEST SPECIMEN.

Fourteen specimens of the type and dimensions shown in Fig. 7 were also cut and tested for brittleness by the impact test, in which a ram or hammer, of

known weight, is allowed to fall from a known height, striking the specimen fairly on its flat side, at the point of least breadth. As a sort of standard of comparison, by which one can gage the performance of the various specimens under this test, it may be well to state that a similar specimen of good modern boiler steel, $\frac{1}{2}$ in. thick, is required by French standards, to withstand a blow from a ram of 28.7 lbs., falling 13.12 feet (13 kilograms, falling 4 meters). This means an expenditure of 374 foot lbs. of work without starting a fracture. These particular specimens were fractured on the average, by a blow from a 26.4 lb. ram, falling 19.7 inches, or with an expenditure of 43.8 foot lbs.

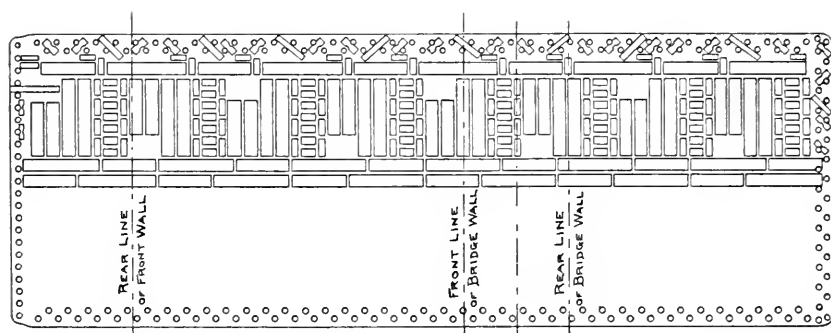
FIG. 8. FIRE SHEET OF C. SAY ET CIE. BOILER NO. 2. SHOWING THE LOCATION OF THE SPECIMENS WITH RESPECT TO THE FIRE.

In 1908, the first two boilers of this battery were to be removed, and the owners gave the opportunity of testing the quality of the material, as they were anxious to see if the steel had deteriorated to such an extent as to render this removal unadvisable. They accordingly gave the lower or fire sheet of the right hand bottom drum of boiler No. 2 for the purpose. This sheet was cut up and tested through the courtesy of the steel works at Denain, who placed their equipment at the disposal of the authors. Fig. 8 will indicate the manner in which the sheet was divided, and will also serve to show how the specimens were placed with regard to the position of the sheet in the boiler.

Cold bend test of 38 specimens, fairly satisfactory. The real extent of the change in this boiler steel was not disclosed until the impact tests were made. 162 impact specimens were tested all told, but as 10 of these were in the nature of special tests, to determine the effect of various sorts of abuse on

this steel, such for instance as hammering it violently when at a blue heat, they were not included in the averages, or percentages to follow. Out of the 152 tests considered to represent the real condition of the material, there were 122 in which the specimens were untreated. Out of this number, 58 specimens failed to pass the test expected of new steel of this class and thickness (7/16 inch) that is to stand without cracking, the impact of a 22 lb. ram, falling 13.12 feet. It was found however, that none of the reheated specimens, whether quenched or not, failed, or that in other words, although the steel was found to have grown brittle, it could be made to fulfill the conditions of the impact test by heat treatment. If we now calculate the percentage failure, we find that based on the whole number broken, 38.1% failed, but if we consider only the untreated specimens, the percentage is seen to be 47.5%. It is also of interest to see where these specimens were located with respect to the grate, the bridge wall, etc., and to see if there is any connection between the percentage of failures, which must be taken to represent the average brittleness of the material, and the sort of treatment it received as regards temperature and heat transfer. It will be seen from the table given that there is such a connection, that it is identical with the changes in the elongation with exposure to the fire, as shown in the table of tensile tests, and that as we should expect, the metal over the grate suffered most, that over the bridge wall next, the metal located behind the bridge less, and that in the front wall and therefore entirely protected from the direct action of the flames, the least of all.

Location.	In Front Wall.	Over Grate.	Over Bridge.	Behind Bridge.
Total number tested	17	45	14	46
No. of Failures	6	26	7	19
No. Intact	11	19	7	27
% Failures	35.5%	57.8%	50%	41.5%
